## CRAM'S FAVORABLE FULL BEAM-LIKE ACTION

## CRAM'S FAVORABLE RESISTANCE TO THE STATIC CHASSIS LANDING GEAR

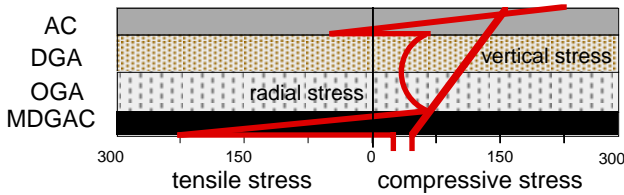
The stress distribution in the CRAM Pavement showing the full beam-like action

The **FULL BEAM-LIKE ACTION** of the **CRAM** pavement was first evident from computer model analyses.

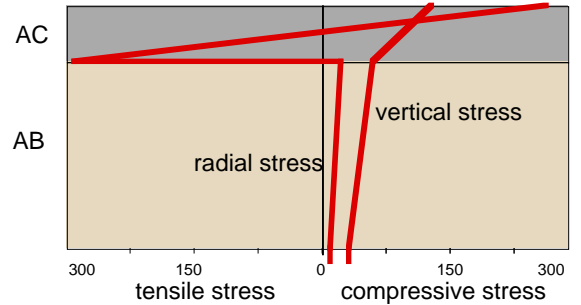
The stress distribution in the Conventional Pavement where the beam-like action is only in the asphalt concrete.

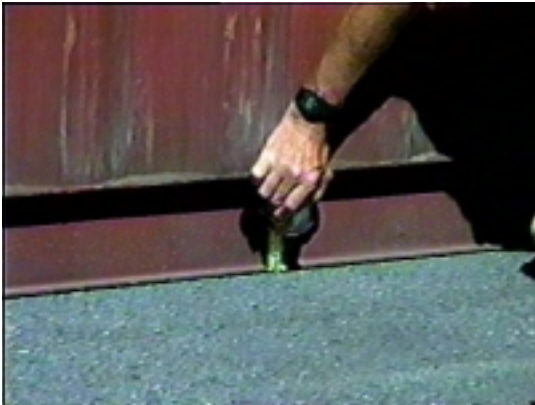
Port of LA CRAM Pavement, typical deformation measurement indicates 1/4" or less rutting in the wheel paths of the top-loader...

Using formulas based on the 1960 Illinois AASHO Road Test which shows the relation between rut depth,  $\Delta$ , load repetitions,  $N$ , and pavement thickness,  $T$ :

$$\Delta = K N^{1/2} / T^{7/2} \quad (3)$$

we compute the equivalent pavement thicknesses for the different rut depths for the CRAM Pavement at the Inter-modal yard for the interior of the phases and where the joint between Phases 1 and 2 occurs:

$$T_2 = T_1 (\Delta_1 / \Delta_2)^{2/7}$$

for  $\Delta_1$  and  $\Delta_2$  equal 0.25 and 1.25, respectively and  $T_1$  equal to 15 inches,  $T_2$  equals 9.5 inches.

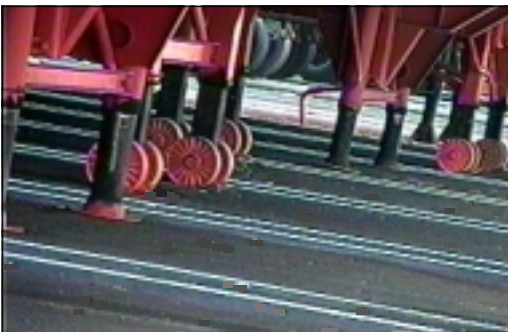
CRAM Pavement; Port of Los Angeles, Berths 127 - 131, supporting loaded chassis landing gear

In the **CRAM** pavement, under loaded chassis, we may see indentations caused by the wheeled landing gear, but **no evidence of depressions**. And, in fact if only the plate landing gear were used, we would be hard pressed to know that the pavement had ever been in use! This is in contrast to the **conventional pavement** which can typically have depressions of 2 to 3 inches after only a few years in service.

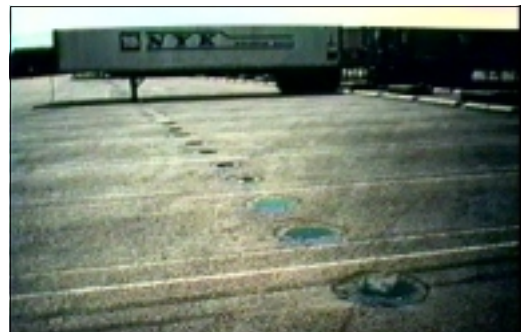
Depressions in the NYK Terminal Conventional Pavement at the Port of Los Angeles caused by loaded chassis landing gear
